Ground Penetrating Radar Survey of the Lithuanian Part of Medzhybizh Castle

Abstract. We present the results of recent geophysical and archaeological investigations conducted in Medzhybizh Castle located in Western Ukraine. Architectural and restoration studies extending over more than half a century have revealed that part of the castle was built during the Lithuanian period, i.e., in the 14th–15th centuries. Our study is focused on *ground penetrating radar* (GPR) surveys investigating the courtyards of the castle including the Lithuanian part, and inside the buildings. The GPR survey was capable of detecting elements of the ancient architecture under a horizon of debris and soil up to 3 m deep. Possible structures of a Lithuanian castle have been suggested and confirmed by recent archaeological excavations. These are fragments of the Western Wall, a stone construction stretching along the façade of the Southern Building, and a fundament ditch of the inner wall in the Southern Building.

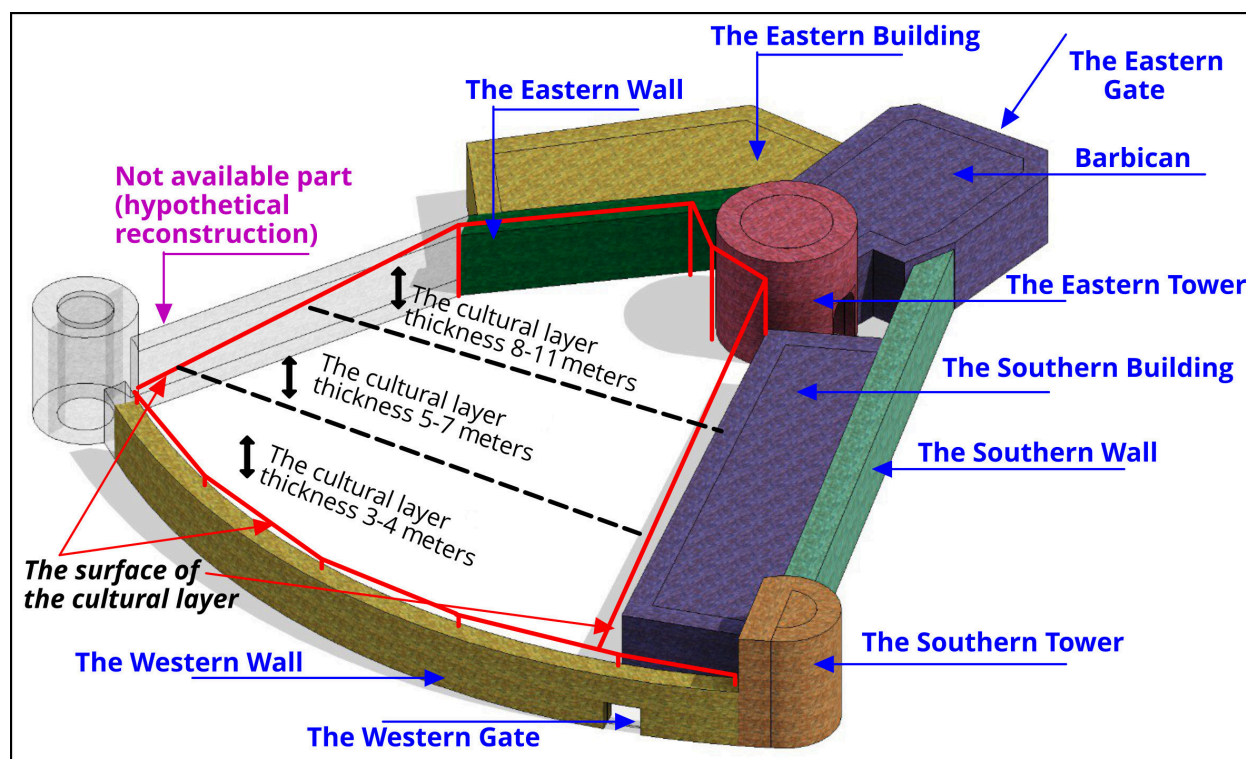
Fig. 2. 3D sketch of the Lithuanian Castle (14th–15th centuries). Thickness of soil filling in different parts of the Lithuanian Castle (reconstruction by V. Vietrov, N. Nizhnik).

During the 14th–15th centuries, the Castle had the shape of an equilateral triangle with sides 60 meters long (Fig. 2). Two construction stages can be identified in the Castle. The first stage probably dates back to the very end of the 14th century, whereas the second stage can probably be referred to the initial decades of the 15th century. The first stage is related to the construction of basic fortification: walls around the perimeter of the Castle, the Towers, and the Barbican. In the second stage, palace buildings appear, one of which is attached from the inside to the Southern Wall (Southern Building), whereas the second palace building is attached from the outside to the Eastern Wall. Thus, in the first half of the 15th century, the castle had two residential buildings of the defense-palace type. Over time, these buildings became the foundations of the Sieniawski-Czartoryski Palace (16th–17th centuries) and the ‘Hetman’s Chambers’ (the Eastern Palace of the 16th–17th centuries). In the 14th century, there were several entrance gates to the Castle. The first entrance was from the West through a system of ditches under the protection of a small semicircular tower. Another one was from the East, under the defense of the Barbican, through a round gate tower.

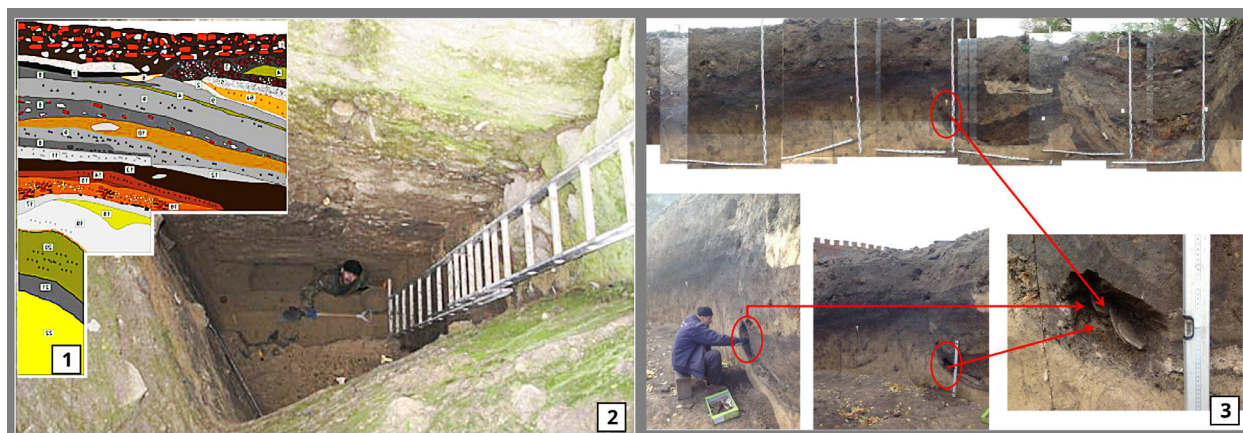
Fig. 3. Sections 3.1 and 3.2. Excavation outside the wall of the Lithuanian Castle (test pit 5, 2018, depth 6.2 m). Section 3.3. Chronological marking of stratigraphy profiles (2022) (photo by V. Vietrov).

In addition, we realized that, in medieval castles, the stratigraphy of adjacent areas can differ significantly due to the local presence of domestic buildings, earthen fortifications, burials, and other objects that may have disrupted the stratigraphy. Therefore, in 2021, taking advantage of the earthwork on the area of the Southern Wall, we laid two stratigraphic profiles with a length of 18 m, a width and a depth of 3 m (Fig. 11). The profiles were located parallel to each other at a distance of 10 meters. In 2021–2022, comprehensive processing of 120 m² of stratigraphic profiles was carried out with clear dating of layers based on typologically significant material and with the use of soil science analyses. A stratigraphic column was composed reflecting the historical periods of the Castle's timeline. On the basis of these works, an unsegmented horizon of the 12th–15th centuries was identified. Its upper part (or its surface) became a stratigraphic marker for processing the Lithuanian Castle zone (Fig. 3.3).

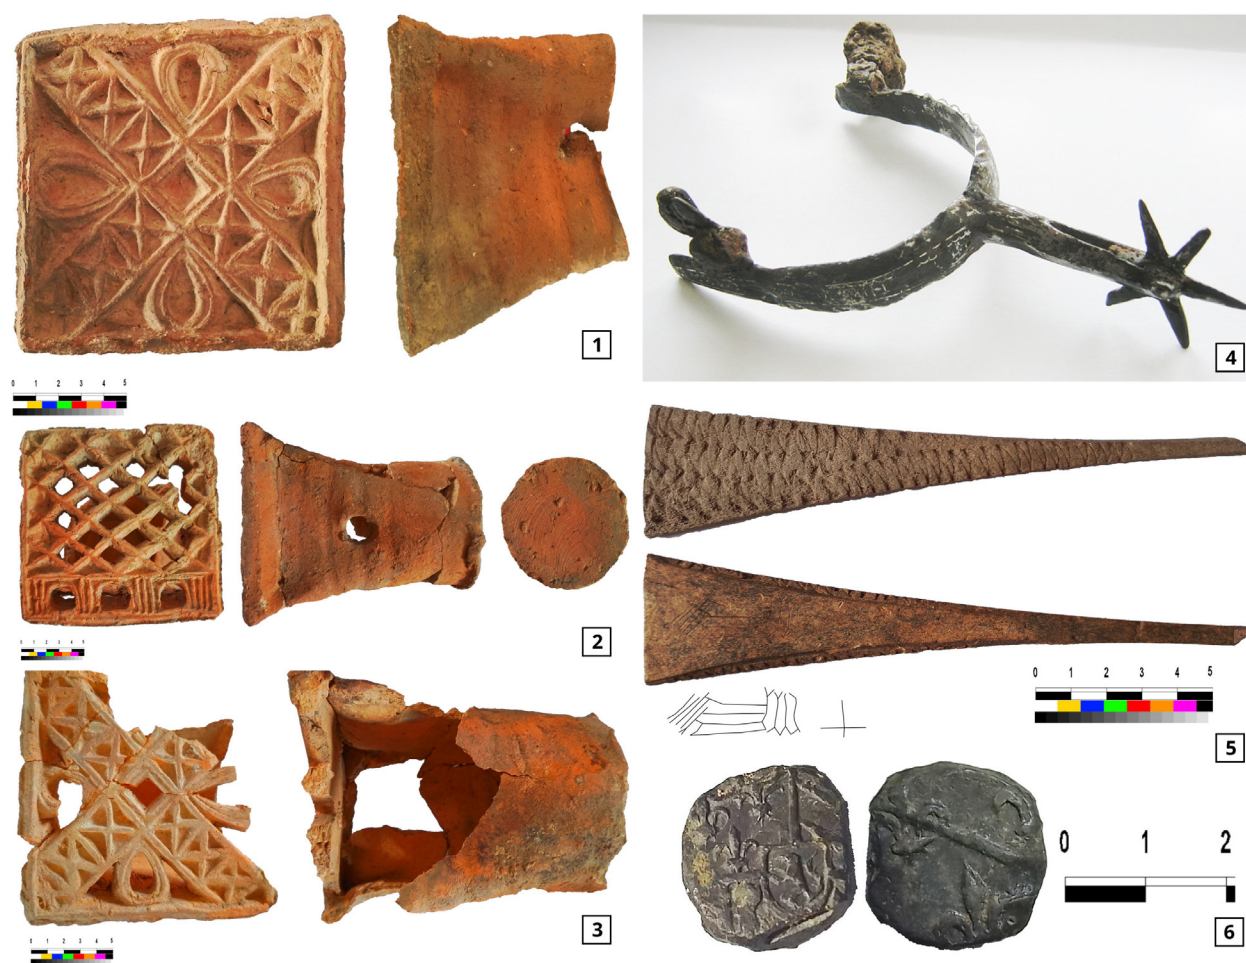
Fig. 4. Section 4.1. Gothic tile of the 15th century. Excavation, 2017. Section 4.2. Gothic slotted tile of the 15th century. Excavation, 2017. Section 4.3. Gothic lattice tile of the 15th century. Excavation, 2017. Section 4.4. A bone stylus with a graphic drawing on the back. 15th century. Excavation, 2017. Section 4.5. The spur was found near the Western Wall of the Southern Building. 14th–15th centuries. Excavation, 2017. Section 4.6. Lead seal. Found near the façade of the South Building. Excavation of 2020. Comparison of image elements with the coat of arms of Philip III the Good, Duke of Burgundy (photo by V. Vietrov).

4 pav. 1 – XV a. gotikinis koklis. 2017 m. tyrimai. 2 – XV a. gotikinis puodyninis koklis su ažūrine plokšte. 2017 m. tyrimai. 3 – gotikinis XV a. koklis. 2017 m. tyrimai. 4 – kaulinis stilius su grafiniu piešiniu. XV a. 2017 m. tyrimai. 5 – pentinas, surastas prie pietinio pastato vakarinės sienos. XIV–XV a. 2017 m. tyrimai. 6 – švininė plomba, surasta prie pietinio korpuso fasado. 2020 m. tyrimai. Plombos paviršiuje išpausti ženklai lyginami su Burgundijos kunigaikščio Pilypo III Gerojo herbu (V. Vietrovo nuotr.).

In 2017, two bone styluses were found in the perimeter of the Lithuanian Castle. The stylus, shown in Fig. 4.5 is analogous to the stylus that was found during the excavations of the Radziwiłł Palace in Dubingiai Castle (Kuncevičius, Laužikas, 2012, 237). The stylus from the excavations of Dubingiai Castle dates back to the 15th century. The category of military ammunition is mainly represented by materials with a wide dating. The arrowheads that have been found are placed in a wider time period of the 13th–15th centuries. Buckles and metal ends of belts are periodized in the same way. At the same time, certain elements of the equipment, such as spurs (Fig. 4.4), have a sufficiently substantiated dating to the 14th century based on analogies of the local monuments (Peskova, 2020, 98–101). Another category of artifacts, which is directly related to the Lithuanian Castle in terms of its location, is crossbow bolts. The first series of crossbow bolts (10 pieces) was discovered in 2009–2015, during excavations near the Western Wall of the Lithuanian Castle (Толкачов, Купрій, 2021, 129, Figs. 1, 2).

To the period of existence of the Lithuanian castle, the lead seal (see Fig. 4.6), which was found near the façade of the Southern Building can be attributed (it is a find of the excavation of 2020). On one side of the seal, in the center of the field of the shield, there is a profile of a lion standing on its hind legs (1), and the space around the shield is divided by lines into four (?) sectors. Lilies (2) are depicted in the upper left sector. In the upper right sector, there are two lines which are slanted from left to right (3). In the lower left sector, there is a vertically elongated silhouette (of an animal (?)). The lower right sector did not enter the field of the lead blank due to a displacement of the die. On the reverse side of the seal, there are images of lilies and a line sloping from left to right. The comparison makes it possible to believe that the image on the seal corresponds to the design of the coat of arms of Philip III, Duke of Burgundy (1396–1467).

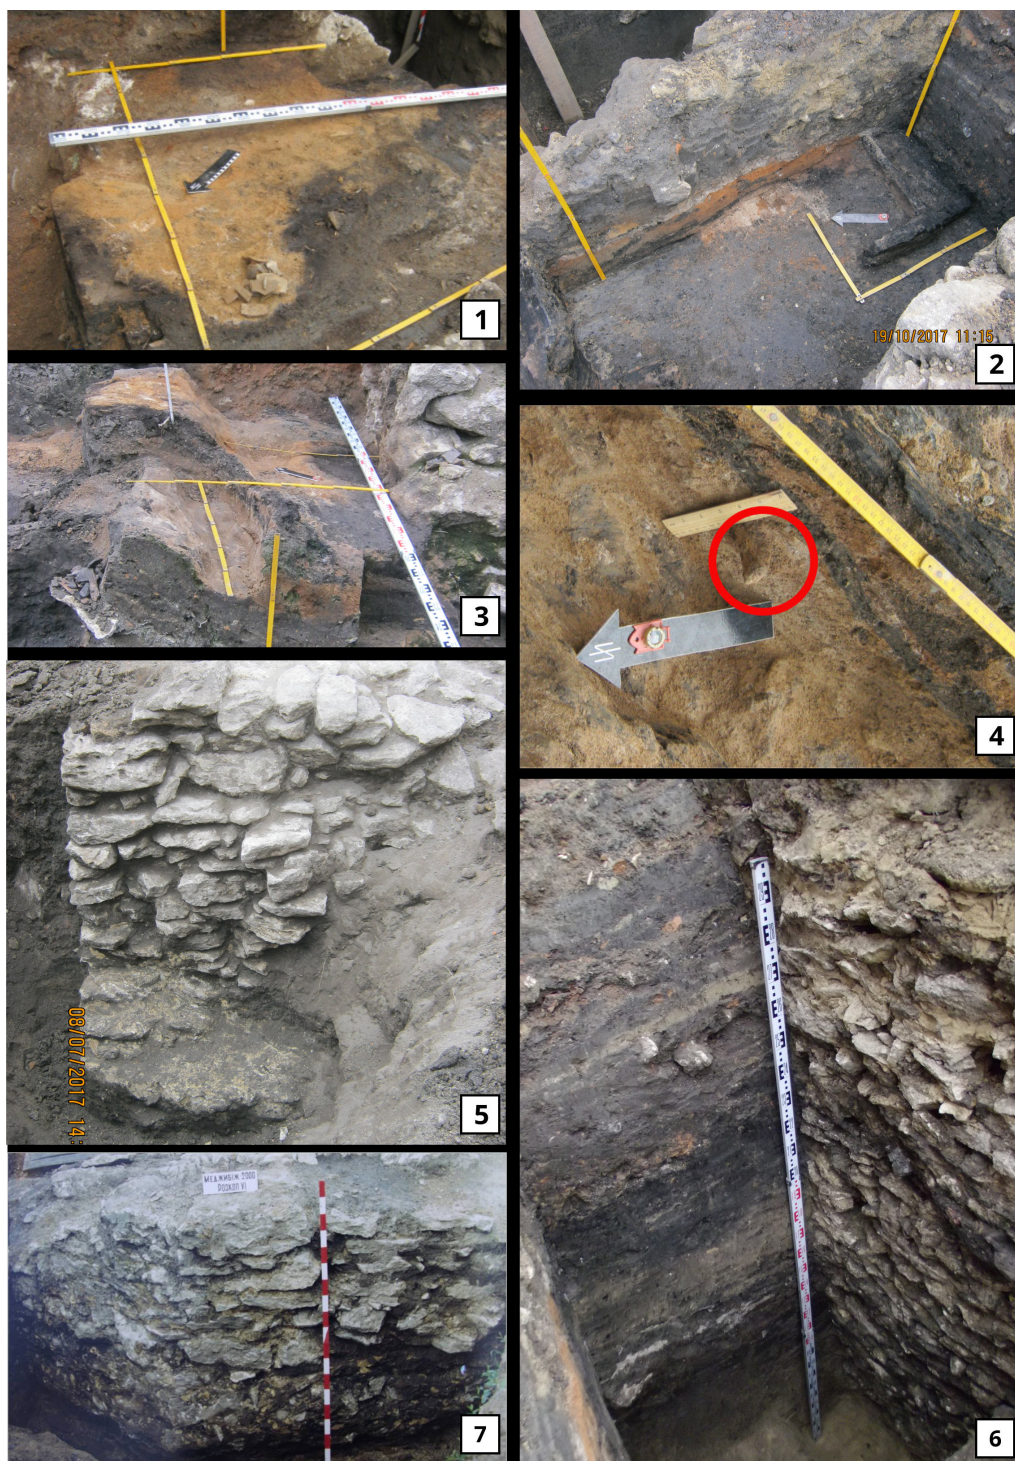
Fig. 5. Section 5.1. Archaeological stripping of the burnt layer (Excavation, 2017). Section 5.2. Fragments of burnt wooden structures (Excavation, 2017). Section 5.3. Archaeological stripping of the surface of burned strata (Excavation, 2017). Section 5.4. Crossbow bolt in a burnt layer (Excavation, 2017). Section 5.5. The Southern end of the Western Wall with the lower platform (Excavation, 2017). Section 5.6. A stone object near the edge of the Western Wall (Excavation, 2017). Section 5.7. Western Wall. Excavation VI, 2000 (photo by V. Vietrov).

of the burned areas indicates that they were displaced, that is, bulk. At the same time, the presence of fragile artifacts (for example, fragments of mesh tiles, or remains of thin burnt wooden structures) in the overfilled soil (Fig. 5.2) indicates that the soil was moved once. It is also obvious that the soil for backfilling was taken from a nearby location. It comes from the area of outdated earthen fortifications of the 14th and 15th centuries, which were probably dismantled. Also, part of the soil could be removed from the foundation pit of the rectangular tower, built in the 16th century on the Southwestern corner of the Lithuanian Castle. In our opinion, the spots of scorched soil are related to the fire that accompanied the storming of the Western Gate of the Lithuanian Castle. The possibility of such events is indicated by the extraordinary concentration of crossbow bolts (Fig. 5.4), which is many times higher than their concentration in other excavations of Medzhybizh Castle. However, it should be noted that, in the area of the Western Gate, as in other excavations, we cannot yet stratigraphically distinguish the day surface of the 14th–15th centuries. Hence, we are dealing with an undivided stratigraphic horizon of the 12th–15th centuries, whereas the objects must be investigated individually, while taking into account the general concept of the periodicity of the development of Medzhybizh Castle.

In the area of the Western Gate, the cultural layer ranges from 2.5 to 3.5 meters. The distance from the day-time surface (with the cobblestones of the 18th–19th centuries) to the top of the undivided horizon of the 12th–15th centuries was about one meter. The height of the Western Wall at the place of the excavation is from 2.0 to 2.5 meters. The wall is built of large blocks of limestone, and held together by limestone mortar. In the central part, the height of the wall is 1.5–2.0 meters (Fig. 5.7), which can be explained by partial dismantling.

At the Southern end, the wall ended with a platform that was 0.5 m wide in the lower part. The probable purpose of the platform is related with the fastening of the gate support or the lattice (Fig. 5.5). It is possible the second part of the gate or lattice fastening was linked to a 3×3×3 meter masonry object which was found in the course of the excavations. It is located three meters South of the Southern end of the wall. The object is built of small limestone blocks stacked on clay mortar. In 2017–2018, we had the opportunity to explore only its top and Eastern edge (Fig. 5.6). Later, its Southern and Northern sides were partially explored (yet not to the bottom of the structure).

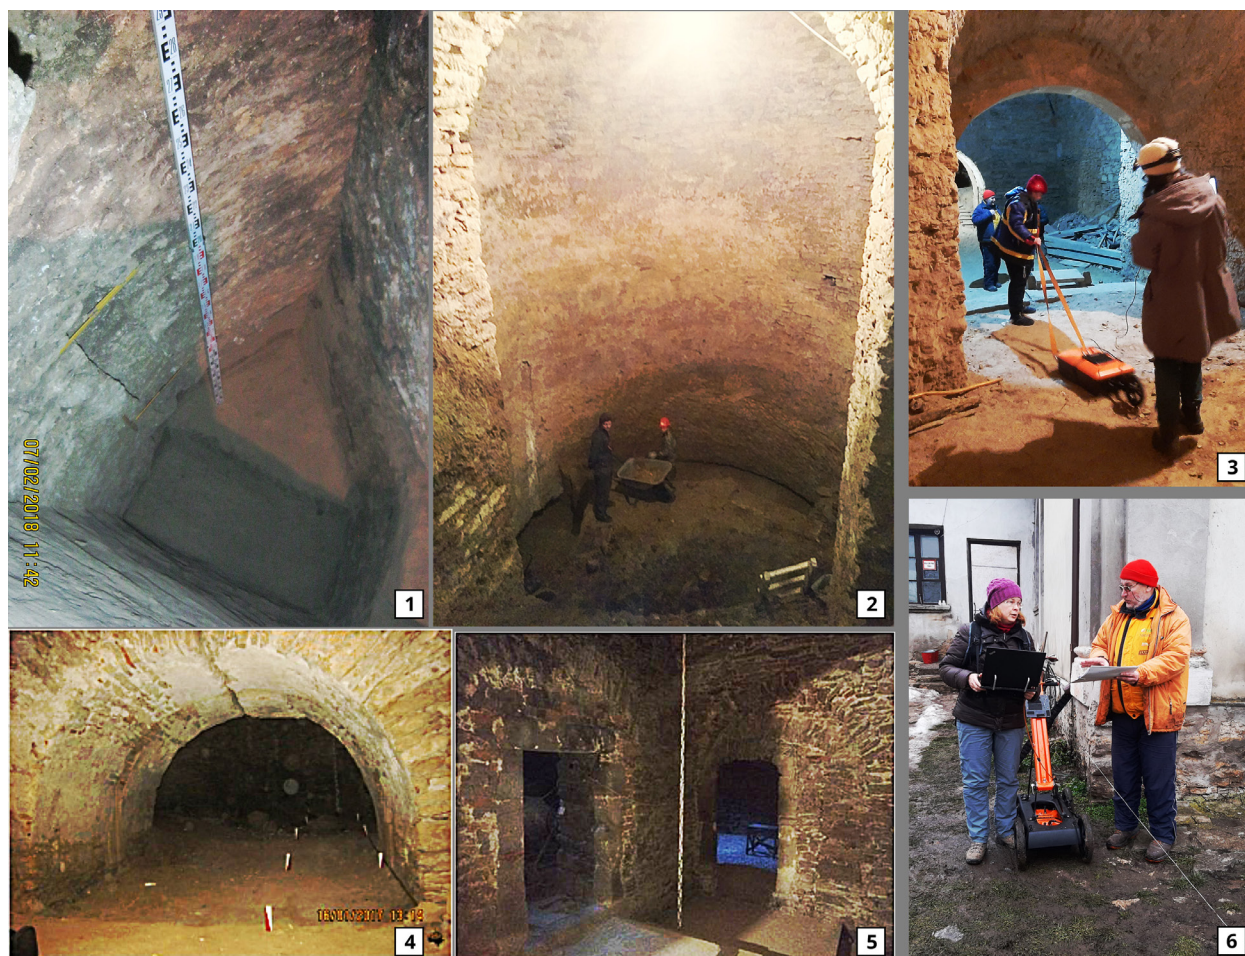
Fig. 6. Section 6.1. Southern Tower. The lower part (Excavation, 2018). Section 6.2. Eastern Tower. The lower tier. A view through the Southern entrance (Excavation, 2020). Section 6.3. Geophysical team performing GPR measurements at the Western entrance to the Barbican. Section 6.4. Barbican. Eastern Gate with portcullis (herse) before the start of archaeological stripping (Excavation, 2017). Section 6.5. Palace (Southern Building). The basement level after archaeological stripping (Excavation, 2019). Section 6.6. Geophysical team performing GPR measurements in the courtyard (Photos 6.1, 6.2, 6.4, 6.5 taken by V. Vietrov; Photos 6.3 and 6.6 taken by K. Bondar).

(Fig. 6:4), which is 1.5 meters above the bottom of the foundation. The Sieniawski-Czartoryski Palace (the Southern Building, which is part of its structure in the basement level) was excavated to the level foreseen by the restorers for its museification (Fig. 6:5). Backfilling of the basement took place in the 19th and 20th centuries. Nowadays, research continues inside all the above outlined buildings, including the use of ground-penetrating radar.

The geophysical technique of GPR has been applied to search for the objects of the times of the Grand Duchy of Lithuania at the Castle (Figs. 6.3, 6.6). The first round of measurements was carried out in 2014 by using a *VIY-2* georadar with a 300 MHz antenna produced by *Transient Technologies LLC* (Ukraine). We recorded radargrams along 6 profiles crossing the yard of the fortress. The second round of GPR prospecting was carried out during a 5-day field campaign in December 2022 (Bondar and Vietrov, 2023). Recent GPR measurements in loess-like loams proved pre-winter and winter months to be mainly suitable for GRP, due to the lowest water content in the deep subsoil. Data were acquired within several long profiles and plots at the courtyard and inside the buildings in the continuous mode along the survey lines (Fig. 7). We used a *VIY-5-37t* (*Transient Technologies LLC*, Ukraine) instrument equipped with ground coupled shielded antennas with nominal middle frequencies of the emitted EM wave at 300 MHz and 700 MHz. Data were acquired in the continuous mode along 0.5 m spaced survey lines in both perpendicular directions, while using 500 samples per trace, a 240 ns time range, and a constant sampling interval of 32 mm along the inline direction. The data were subsequently processed by using standard two-dimensional processing techniques while employing the *Synchro3* software (*Transient Technologies LLC*, 2004).

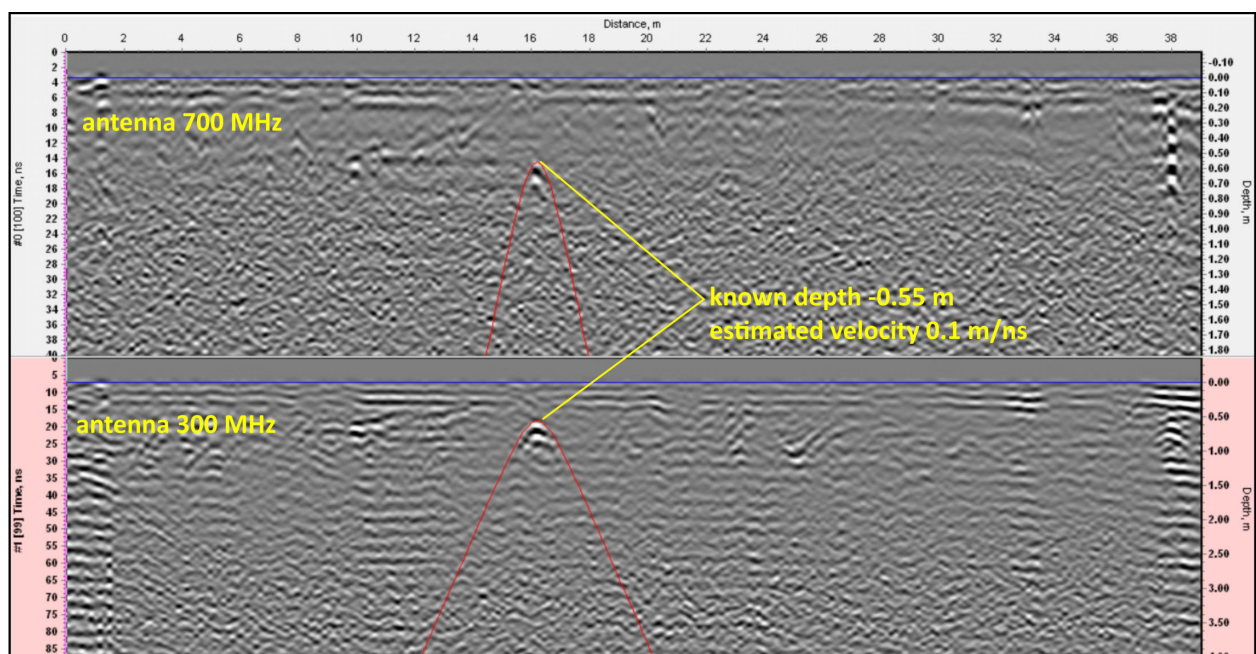
Fig. 7. Radargrams along the D28 profile (for the location, see Fig. 2) showing a reflection from the water pipe in the courtyard.
 7 pav. D28 profilio radarograma (vieta pažymėta 2 pav.), parodanti atspindį nuo vandentiekio vamzdžio kieme.

low-frequency fluctuations and high-frequency noise; (II) the windowed background removal tool subtracts an averaged trace from each trace of the profile, with the width of the window for averaging specified by the total number of traces; (III) manual gain, to adjust the acquisition gain function and enhance the visibility of deeper anomalies. By using the *Planner* software, the radargrams were subsequently merged into three-dimensional volumes and visualized in various ways to enhance the spatial correlations of anomalies of interest. The average electromagnetic wave velocity was estimated as 0.1 m/ns from the hyperbolic adjustments of the diffraction hyperbolas of the known water pipe located at the site (Fig. 7).

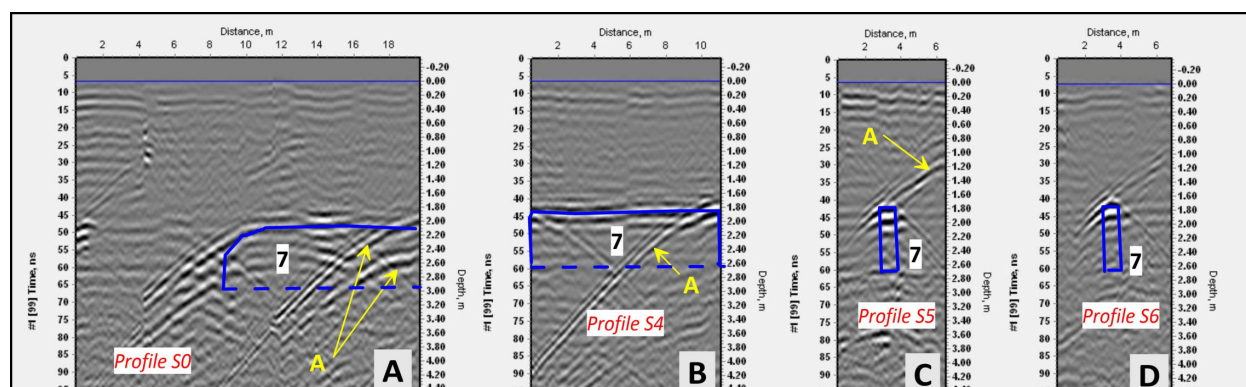
Fig. 10. GPR survey results from Sieniawski's Palace. Examples of radargrams with characteristic anomalies are explained in the Legend in Fig. 11. The positions of the corresponding GPR profiles are shown in Fig. 8.2.

GPR measurements inside Sieniawski's Palace were conducted by a series of profiles, as shown in Fig. 8.2. Radargrams collected along profiles S0 and S4 show linear anomalies associated with the contrast structure 7, which was initially interpreted as a wall. It shows up in this particular way due to the parallel position in relation to these GPR profiles. The hyperbolic anomalies at 42 ms in Profiles S5 and S6 are interpreted as reflections from the 'wall-like' structure 7, as the profile is located perpendicular to it.

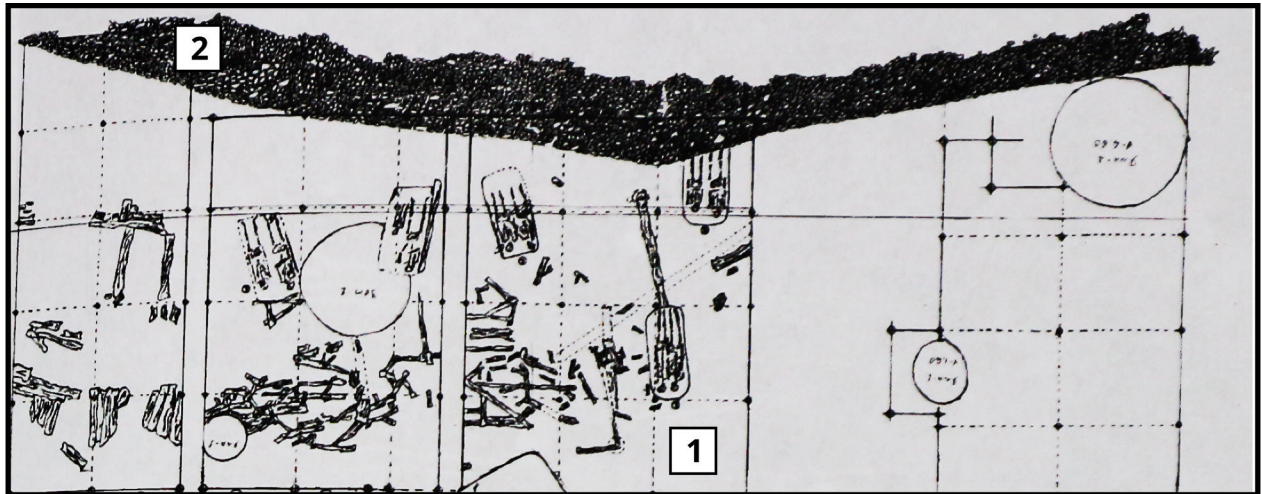
Fig. 12. Anomaly 2. Objects outside of the Western Wall (central sector). Section 12.1. Ground cemetery. Section 12.2. Outer contour of the Western Wall.

Anomaly 2 records the central part of the Western Wall of the Lithuanian Castle (see Fig. 12.2). The surface of the Western Wall was in the zone of excavations and test pits at different times. Hence, its structure has been traced in general. According to the results of archaeological research, the plan of the wall corresponds to the scheme of the Lithuanian Castle, which was drawn by E. Lopushynska.

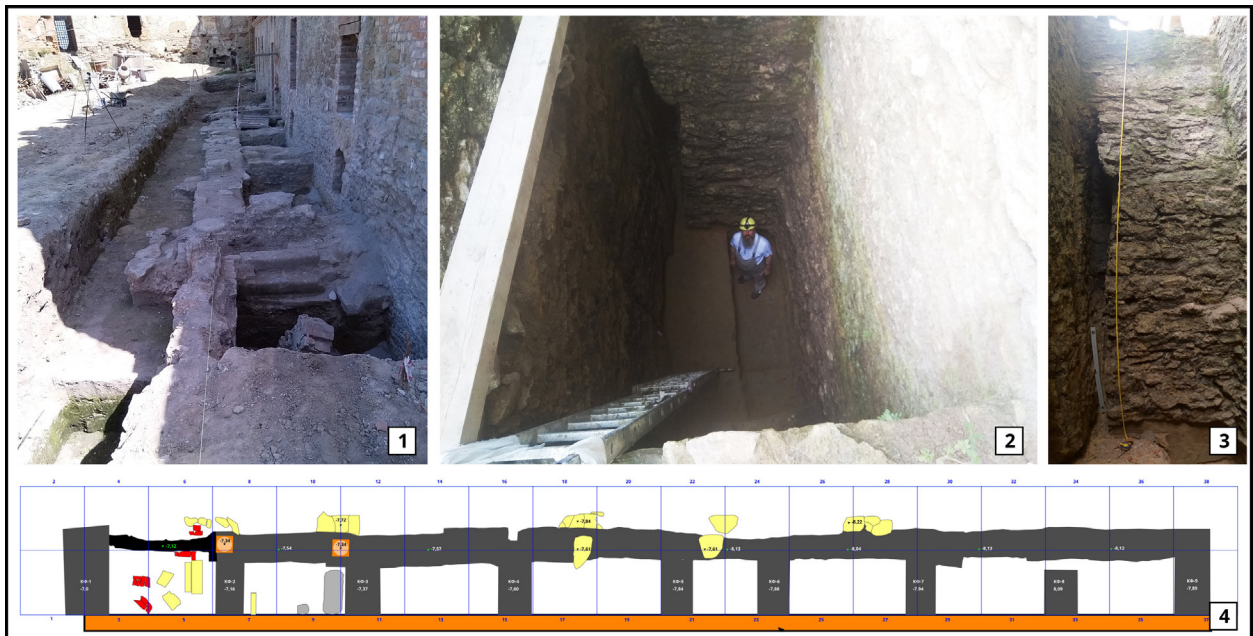
Fig. 13. Object detected at the site of anomaly 3. The wall with buttresses is located along the façade of the palace. Section 13.1. Western part of the excavation. Section 13.2. Excavated part of the wall (depth 5 meters). Section 13.3. Buttress of the wall, built from the façade of the Palace (depth 5 meters) (Photo by V. Vietrov).

In zone 3, in the central part of the Lithuanian Castle, an unknown masonry structure measuring a total length of 36 m was discovered. It is located along the Northern façade of Sieniawski's Palace (Figs. 13.1, 13.4). The structure is built like a wall which is 1–1.5 m wide. From the Southern side, it rests on nine brick rectangles measuring 2×1 m. They are designed together with the Northern façade of the Palace. The building is constructed of natural limestone blocks. Its masonry is made with clay and limestone mortar. According to archaeological stripping in two sections at the bottom of the structure, it is possible to state that it has a height (or depth from top to bottom) of 5–6 m (Figs. 13.2, 13.3). One more feature of this facility is a colonnade platform along the Palace façade. On top of the structure, there were two lower parts of columns which were carved from limestone. The object was discovered and studied in 2019–2021.

In this regard, interpretations of objects associated with the Southern Building (anomalies 3 and 7) are promising. Anomaly 3 recorded the huge stone wall, resting on nine 2.0×1.2 meter rectangles built into the structure of the Northern façade of the Southern Building. Its length is 36 meters, and it is 5 meters high. The dating of this structure brings us to the 14th–15th century, which can be based on the analysis of construction technologies. The wall masonry is mainly made of clay mortar. However, we do not find such archaic technology in the building structures of Medzhybizh Castle of the 16th–18th centuries.

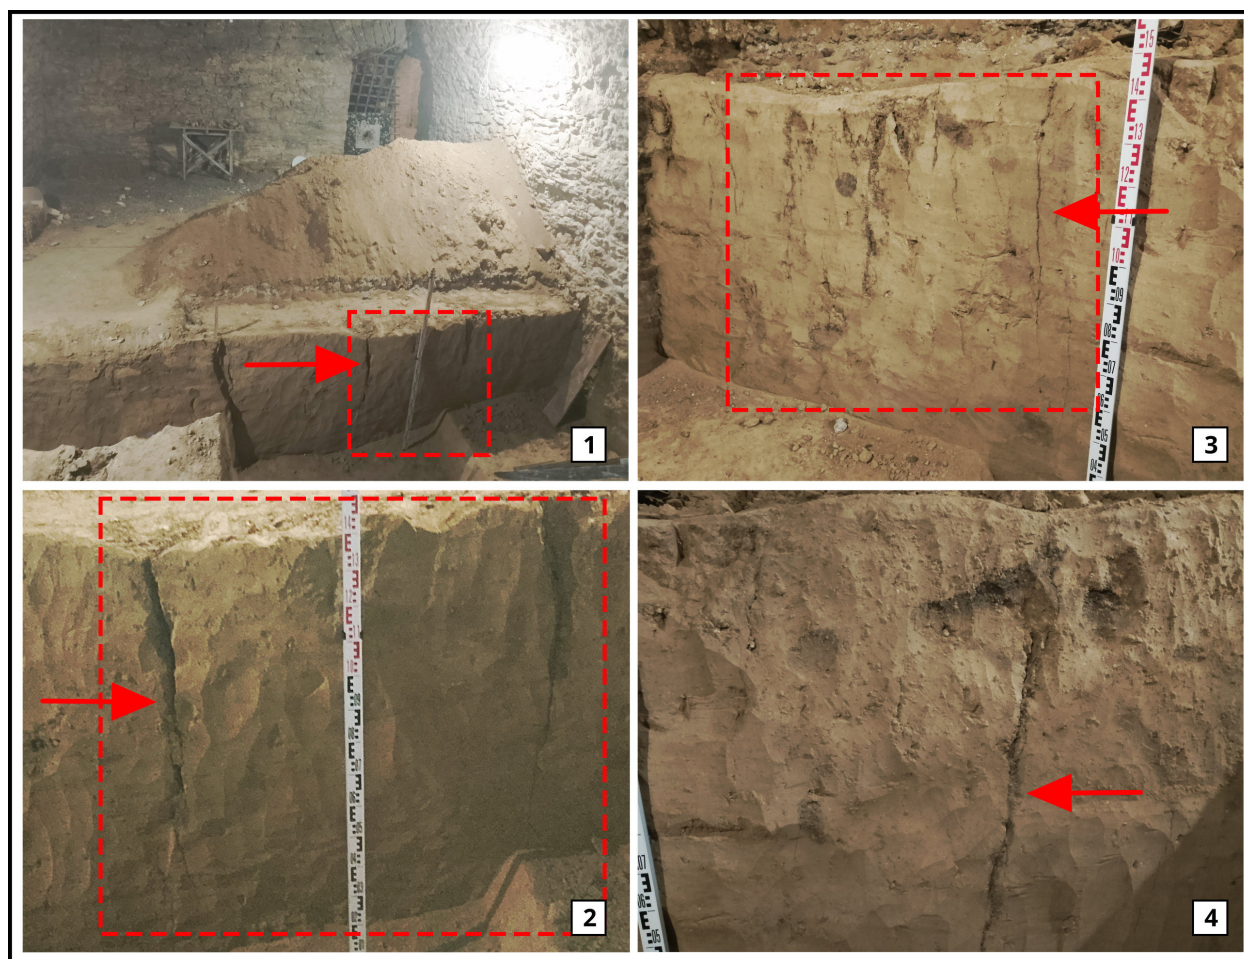
Fig. 14. Anomaly 7. Anomaly sizes are indicated with tape. Section 14.1. Western side of the trench. Section 14.2. Vertical cracks along the edges of the anomaly. Section 14.3. Eastern side of the trench. Section 14.4. Crack along the Southeastern edge of the anomaly (Photo by V. Vietrov).

interpreted as a wall running from East to West, parallel to the South Wall. To fix the found object, a 6×2 meter trench to a depth of 1.5 m was laid across its long axis (Fig. 14).

Excavations determined that the anomaly indicated a section of loess soil of a width of 1.3 m. The section is observed in both walls of the trench (Fig. 14). Its boundaries are marked by vertical cracks in the loess soil. These cracks can be seen especially clearly on the Western side of the trench (see Figs. 14.1, 14.2). The internal volume, between the cracks, is extremely dense.
